Recreational Use Attainability Analysis for Buffalo Creek (0214B), Paradise Creek (0230A), and Sweetwater Creek (0299A) in the Red River Basin

DRAFT for PUBLIC REVIEW

Prepared for:
Texas State Soil and Water Conservation Board
Project 12-52

TR 1308

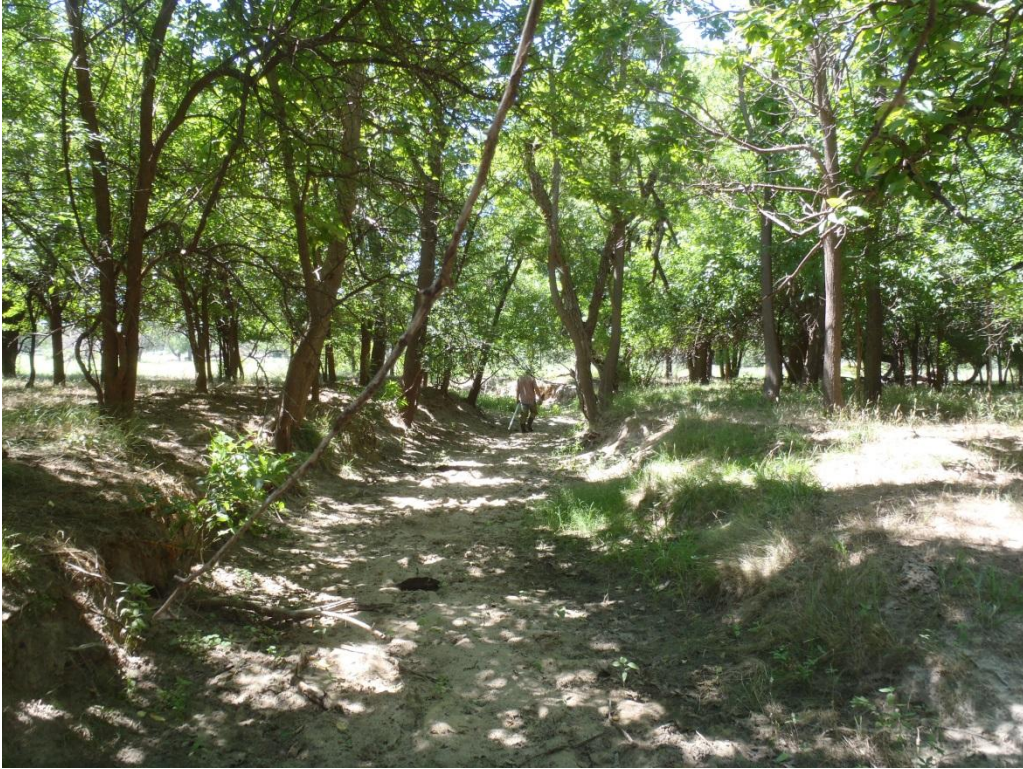
Figure 5.41 Photograph of Sweetwater Creek Site SW016 taken on July 28, 2013, the upstream view of the 150-m transect. TIAER personnel in the photograph.

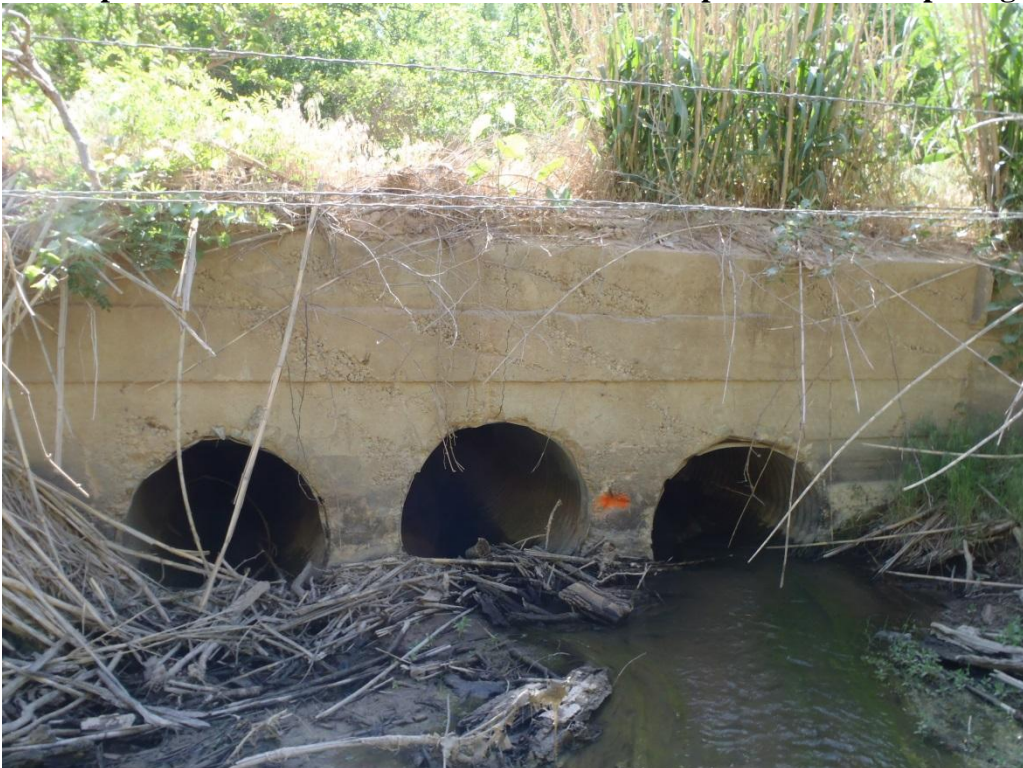
Site SW016 was wadeable for the entire 300-m reach length. Average thalweg ranged from 0.20 m during the first survey to 0.0 m during the second survey when the stream was dry (Table 5.6). During both surveys, the sandy substrate and shallow to non-existent water depths made wading in the stream channel easy. Widths of the stream ranged from a maximum of 3.6 m during the first survey to a minimum of 0.0 m during the second survey when no water was present (Tables 5.7 and 5.8). The only obstructions encountered were the barbed wire property fence and the concrete culvert; both located just below the 0-m transect (Figure 5.42).

Figure 5.42 Photograph of Sweetwater Creek Site SW016 taken on May 27, 2013 showing the concrete culvert and property fence.

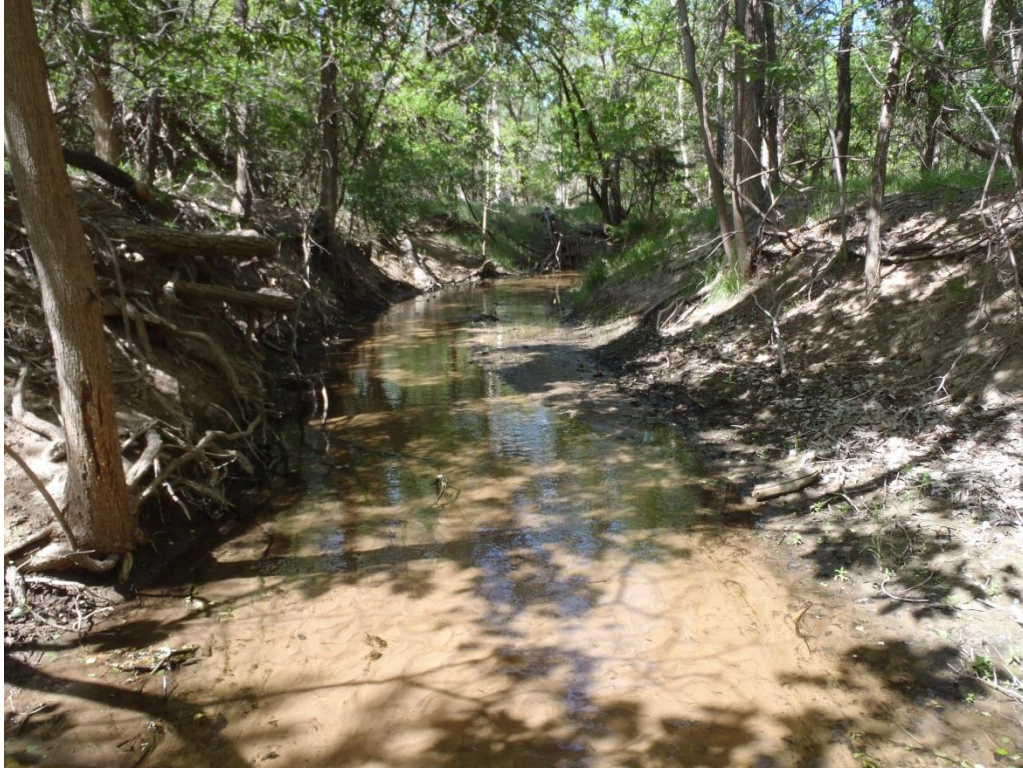
Figure 5.43 Photograph of Sweetwater Creek Site SW017 taken on May 27, 2013, the upstream view of the 300-m transect.

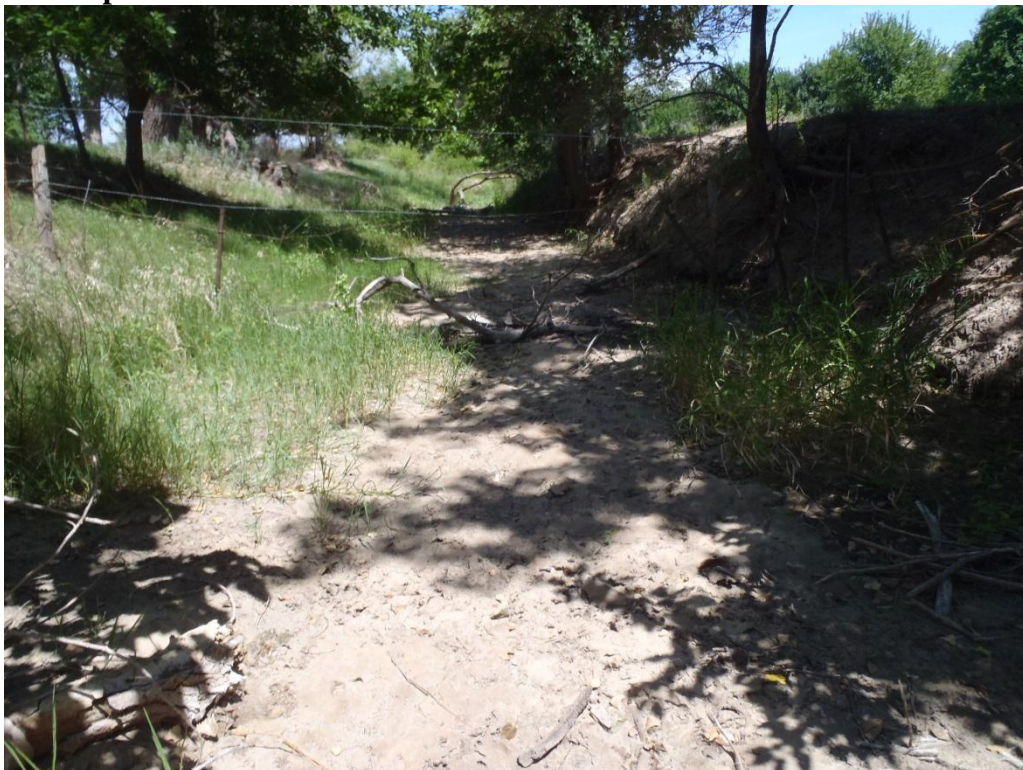
Site SW017 was wadeable for the entire 300-m reach length. Average thalweg ranged from 0.13 m during the first survey to 0.0 m during the second survey when the stream was dry (Table 5.6). During both surveys, the sandy substrate and shallow to non-existent water depths made wading in the stream channel easy. Widths of the stream ranged from a maximum of 4.8 m during the first survey to a minimum of 0.0 m during the second survey when no water was present (Tables 5.7 and 5.8). The only obstructions encountered were the barbed wire property fence (Figure 5.44) and small log jam, both located near the 150-m transect.

Figure 5.44 Photograph of Sweetwater Creek Site SW017 taken on July 29, 2013, the downstream view of the 150-m transect.

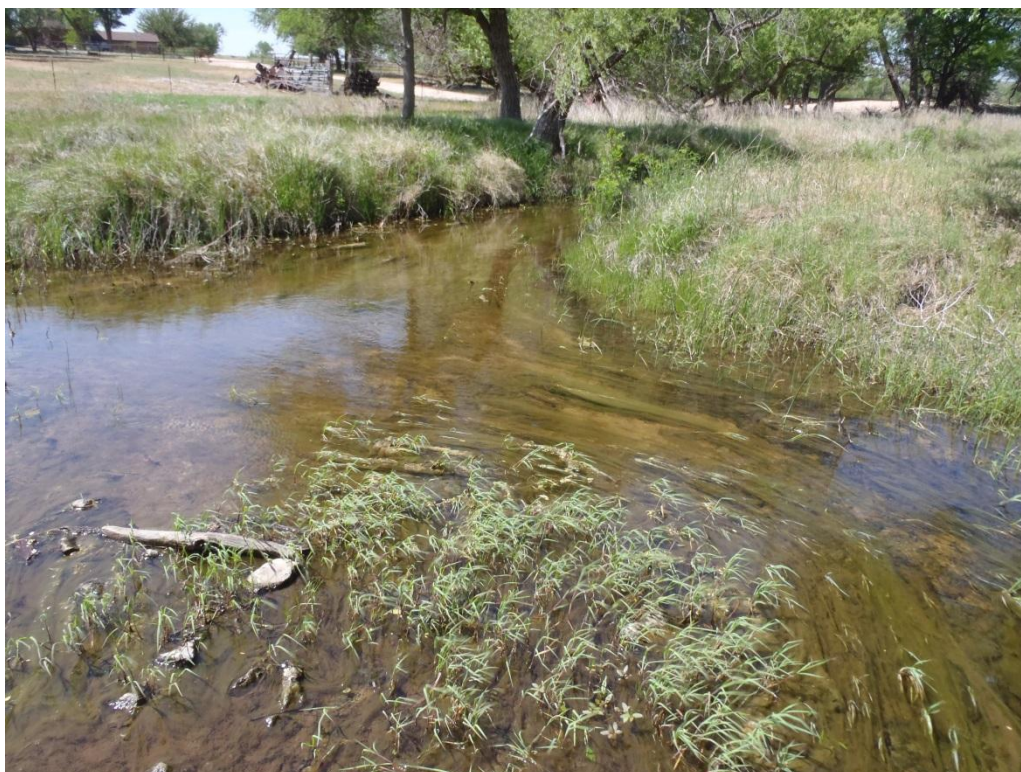
Figure 5.45 Photograph of Sweetwater Creek Site SW018 taken on May 27, 2013, the upstream view of the 300-m transect. Landowner's house in background.

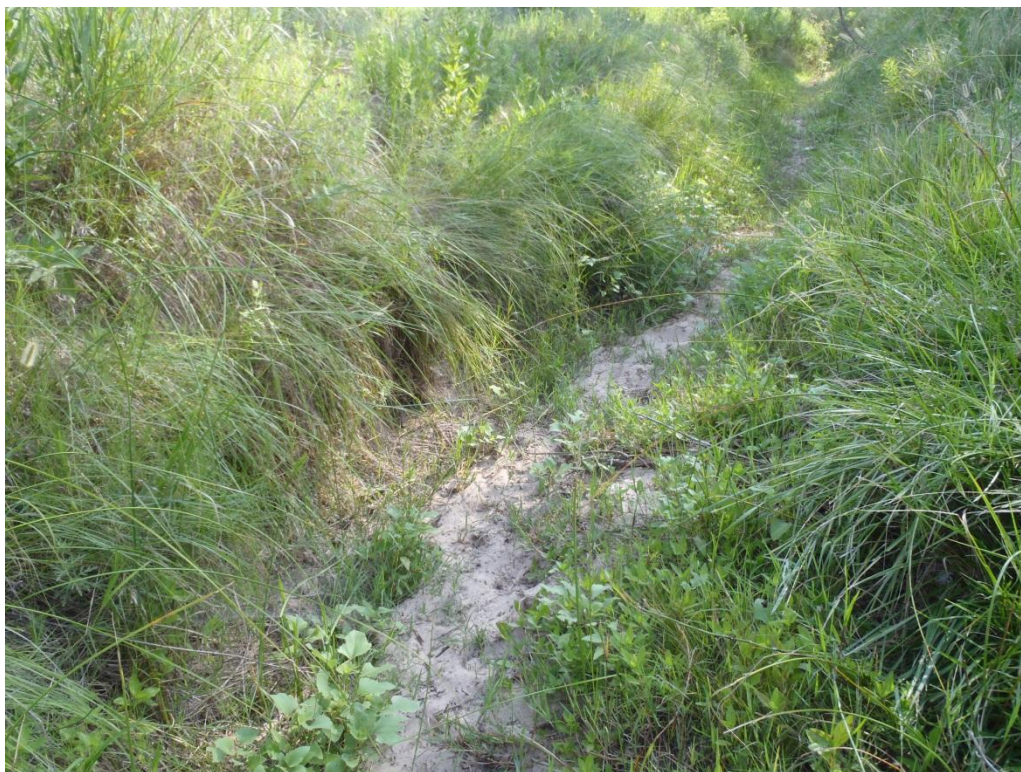
Figure 5.46 Photograph of Sweetwater Creek Site SW018 taken on July 29, 2013, the downstream view of the 30-m transect.

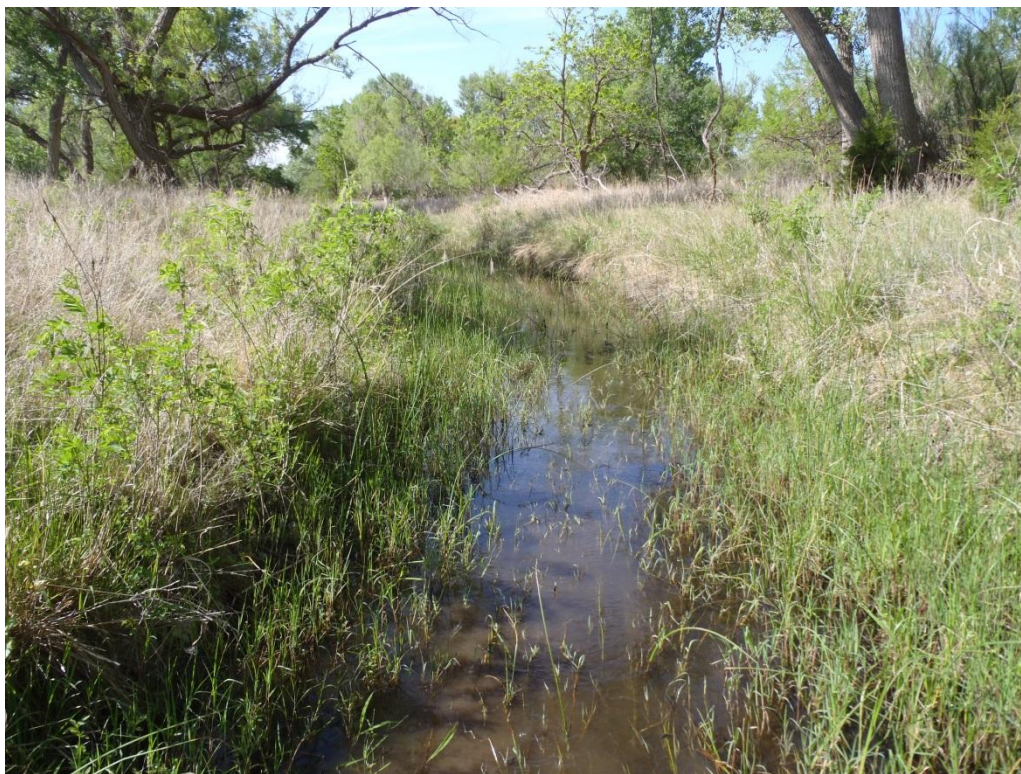
Figure 5.47 Photograph of Sweetwater Creek Site SW019 taken on May 27, 2013, the downstream view of the 30-m transect.

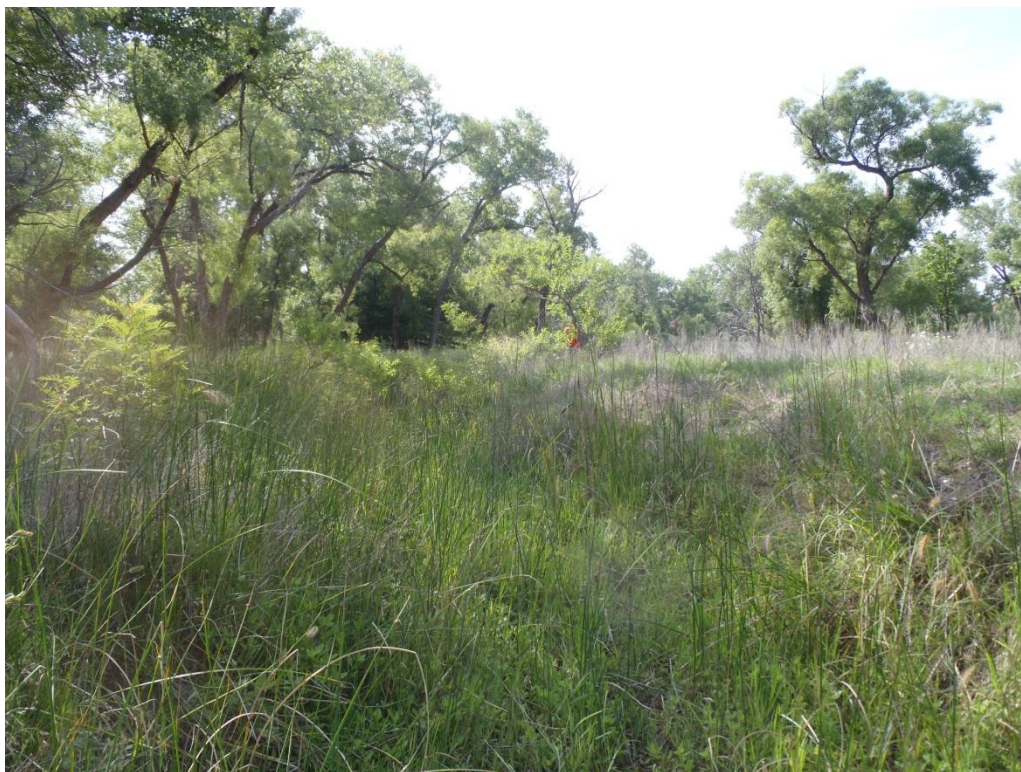
Figure 5.48 Photograph of Sweetwater Creek Site SW019 taken on July 29, 2013, the downstream view of the 300-m transect.

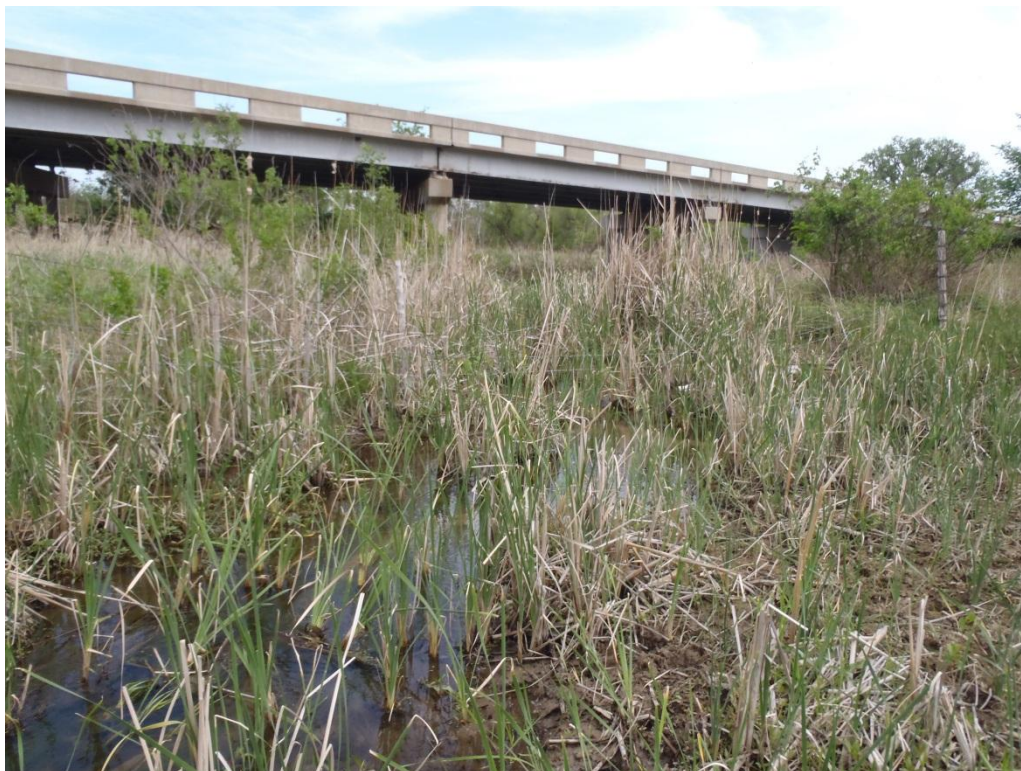
Sweetwater Creek at site SW020 was visited on May 27 and July 29, 2013. This site, located north of Wheeler, Texas in Wheeler County, was accessible through private land that was fenced and required landowner permission to access. Although the site is listed as being publicly accessible, access is limited to approximately 20 meters upstream and downstream of the bridge crossing on State Highway 83 due to a barbed wire fence (Figure 5.49). With permission from the landowner,

Figure 5.49 Photograph of Sweetwater Creek Site SW020 taken on May 27, 2013, the downstream view of the 30-m transect showing the barbed wire property fence.

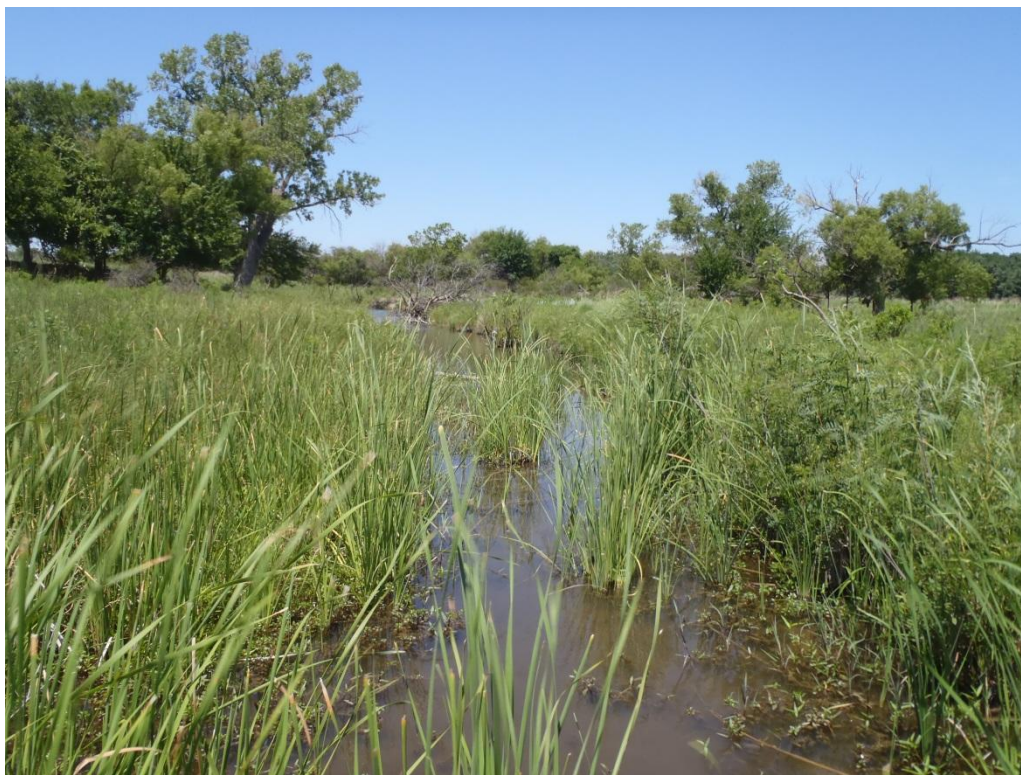
Figure 5.50 Photograph of Sweetwater Creek Site SW020 taken on July 29, 2013, the upstream view of the 150-m transect.

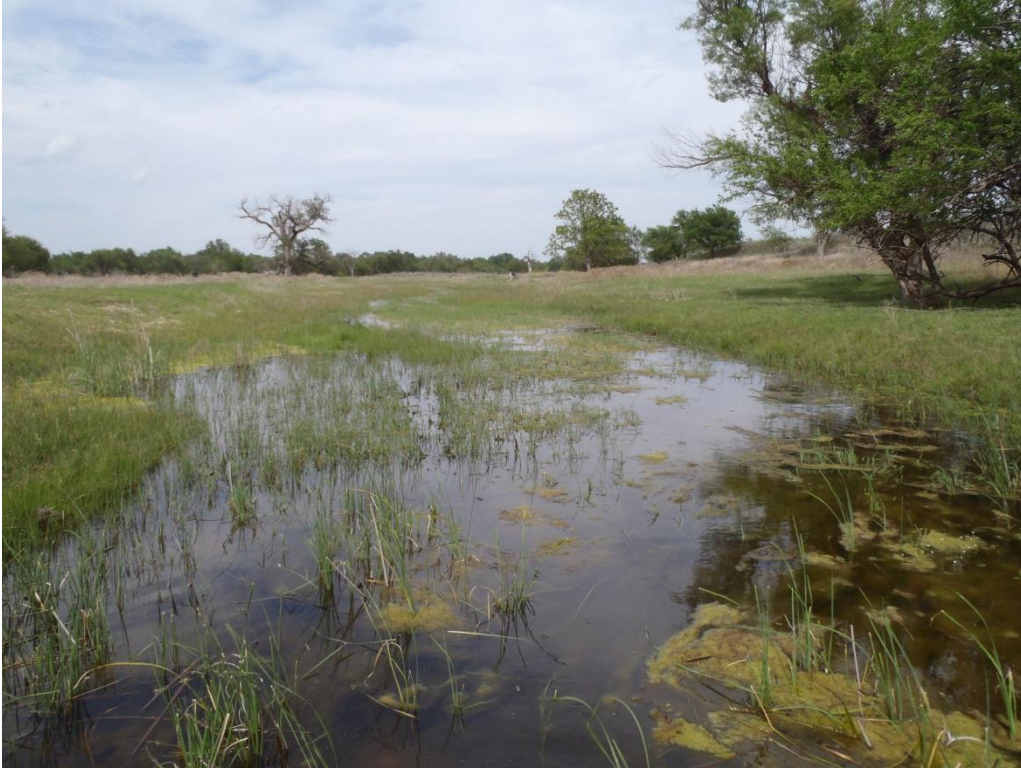
Figure 5.51 Photograph of Sweetwater Creek Site SW021 taken on May 27, 2013, the downstream view of the 300-m transect.

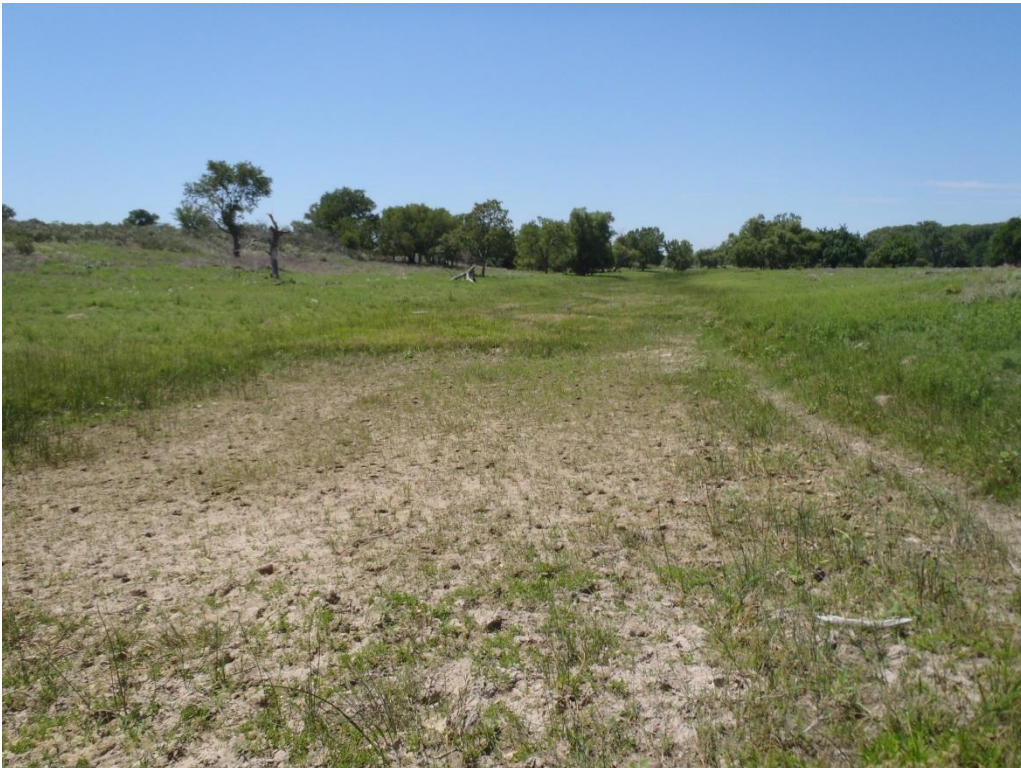
Figure 5.52 Photograph of Sweetwater Creek Site SW021 taken on July 28, 2013, the upstream view of the 150-m transect.

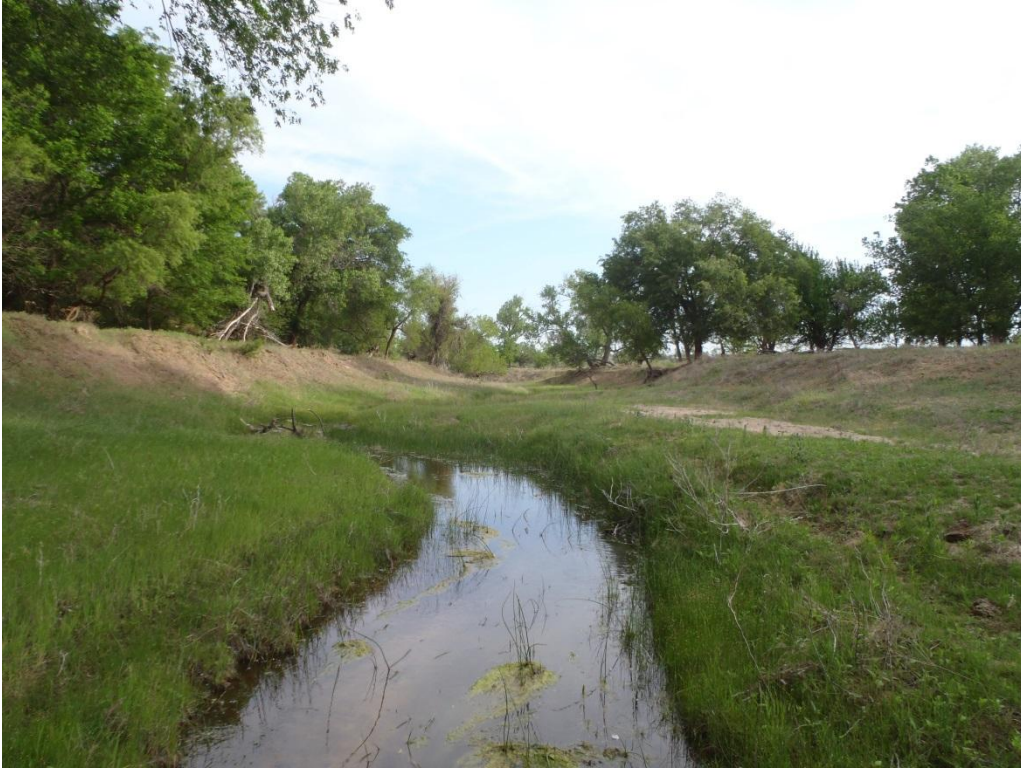
Figure 5.53 Photograph of Sweetwater Creek Site SW022 taken on May 28, 2013, the upstream view of the 150-m transect.

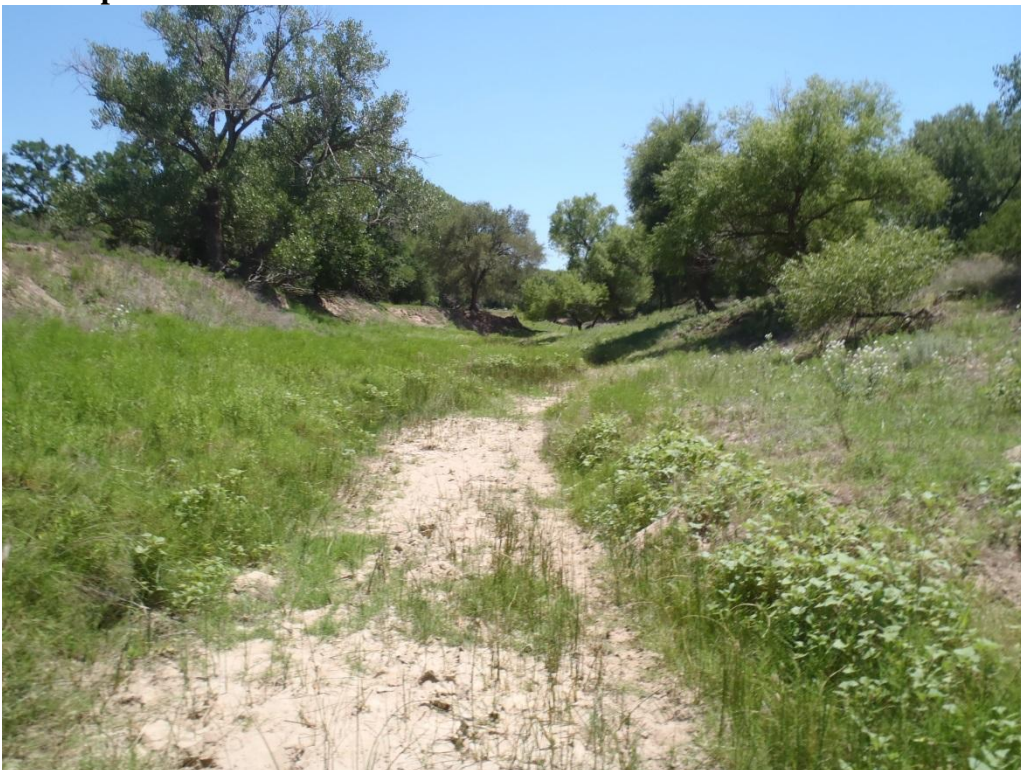
Figure 5.54 Photograph of Sweetwater Creek Site SW022 taken on July 28, 2013, the downstream view of the 300-m transect.

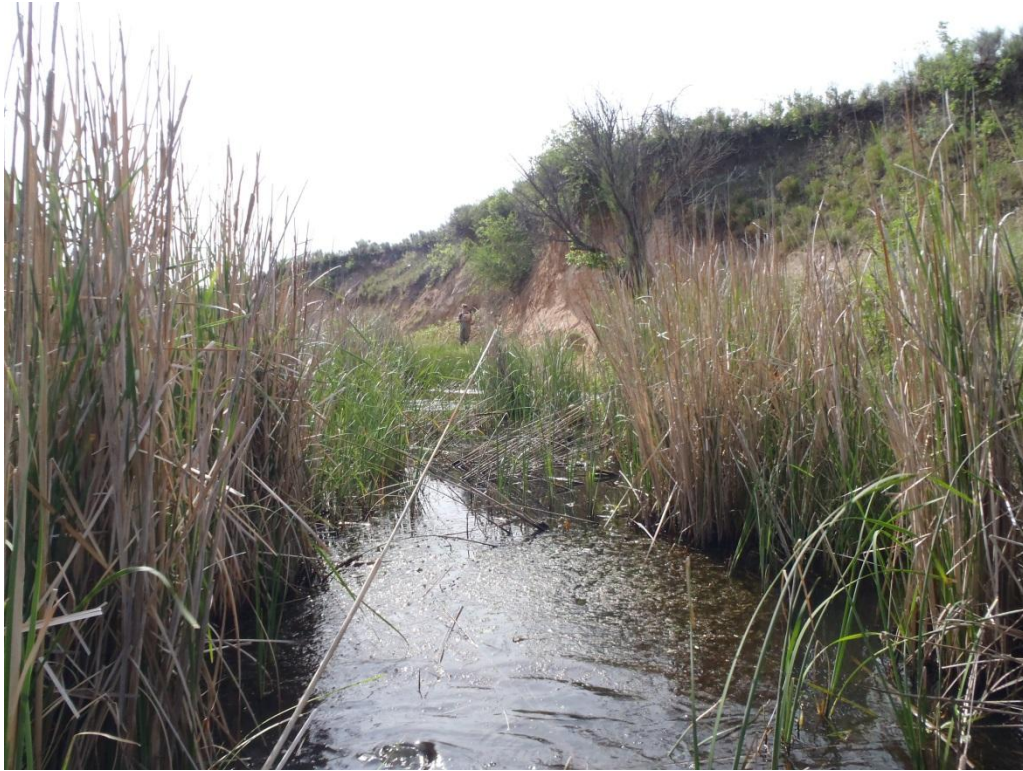
Figure 5.55 Photograph of Sweetwater Creek Site SW023 taken on May 28, 2013, the downstream view of the 300-m transect. TIAER personnel in photograph.

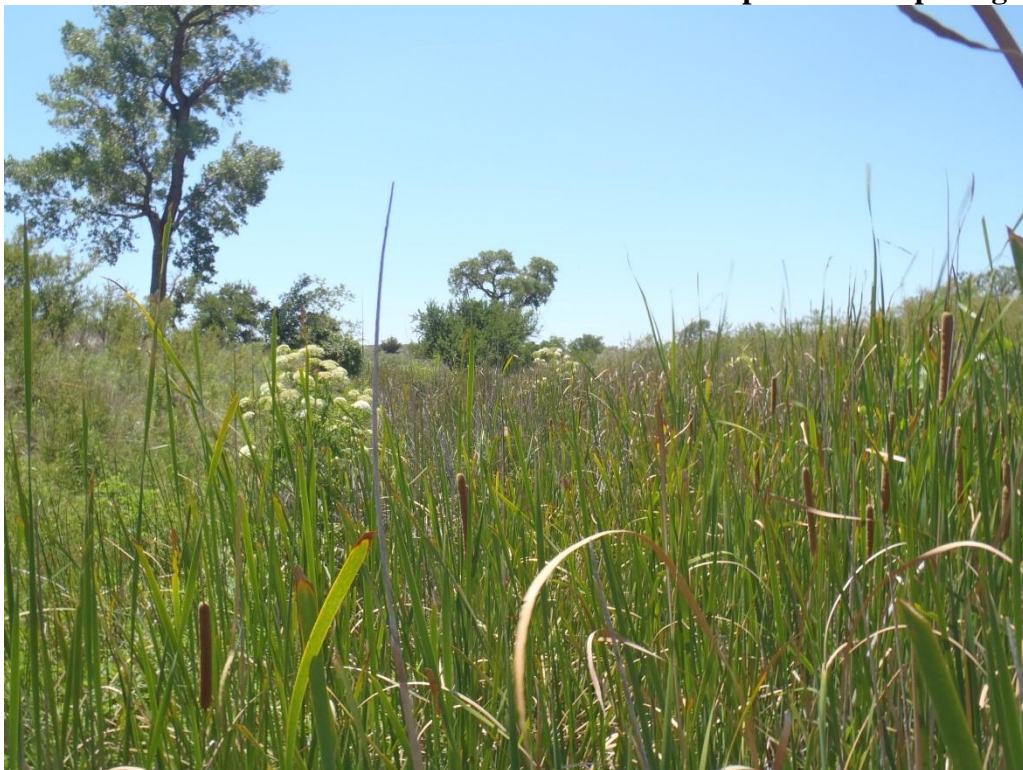
Figure 5.56 Photograph of Sweetwater Creek Site SW023 taken on July 28, 2013, the upstream view of the 30-m transect.

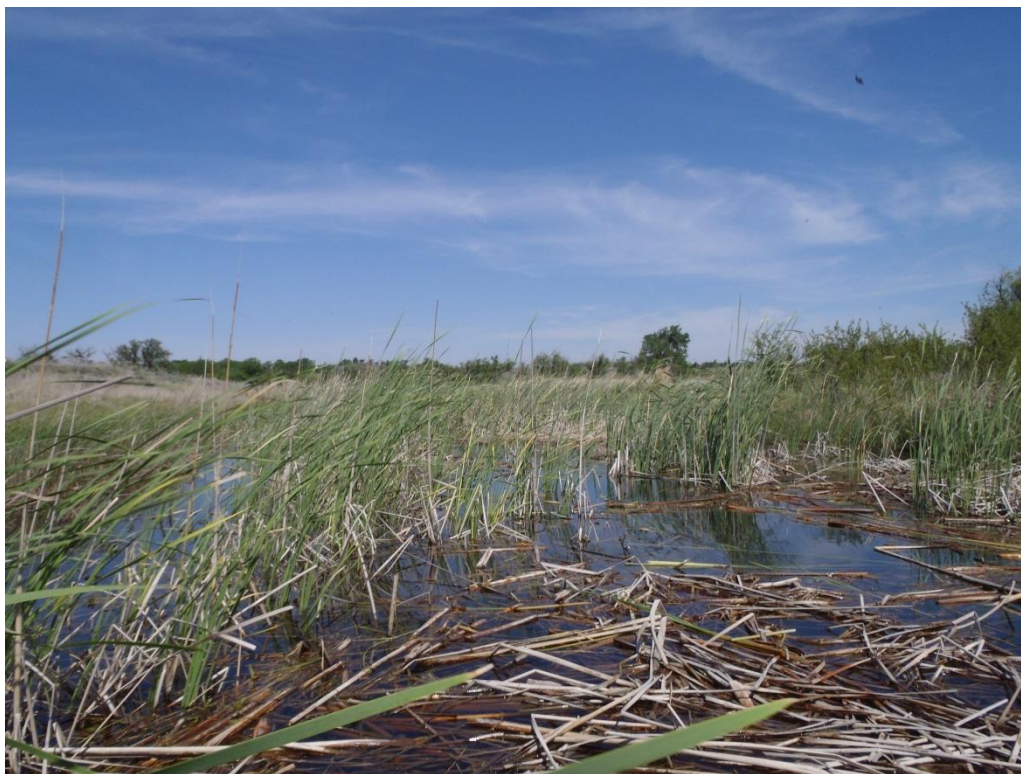
Figure 5.57 Photograph of Sweetwater Creek Site SW024 taken on May 26, 2013, the upstream view of the 30-m transect.

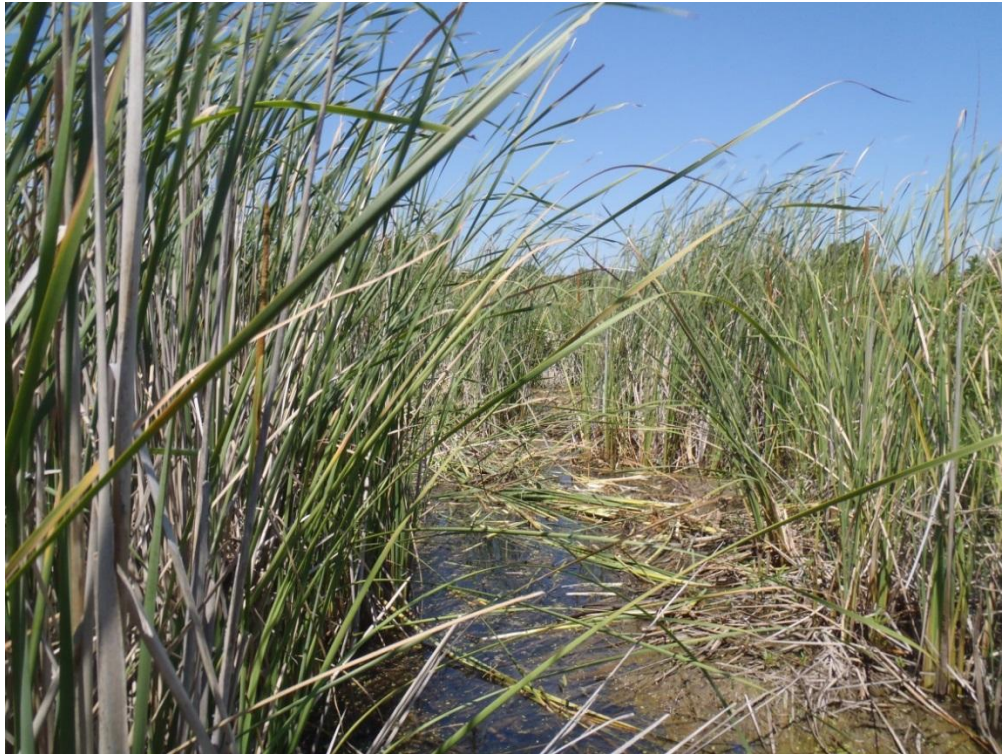
Figure 5.58 Photograph of Sweetwater Creek Site SW024 taken on July 28, 2013, the upstream view of the 150-m transect.

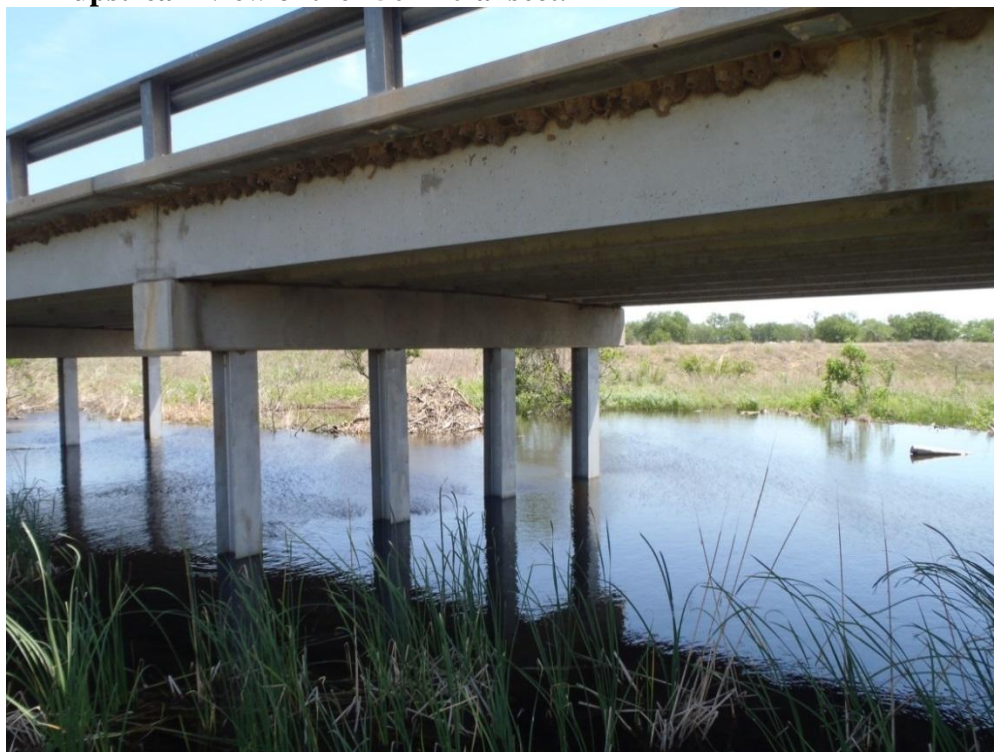
Site SW024 was wadeable for the entire 300-m reach length, although it was challenging. There was a beaver dam with a hut on the downstream side of the bridge crossing Ranch Road 3182 and water was backed up for a large distance upstream (Figure 5.59). The study reach was determined to be one large pool greater than 300 meters long with a maximum depth greater than 1.4 meters and a maximum width of 14 meters during the first survey. During the second survey, the maximum width was 13 meters with a maximum depth of 1.1 meters. Average thalweg was >1.0 m during the first survey and 0.70 m during the second survey (Table 5.6).

Figure 5.59 Photograph of Sweetwater Creek Site SW024 taken on May 26, 2013 showing the beaver hut located on the downstream side of the bridge crossing Ranch Road 3182.

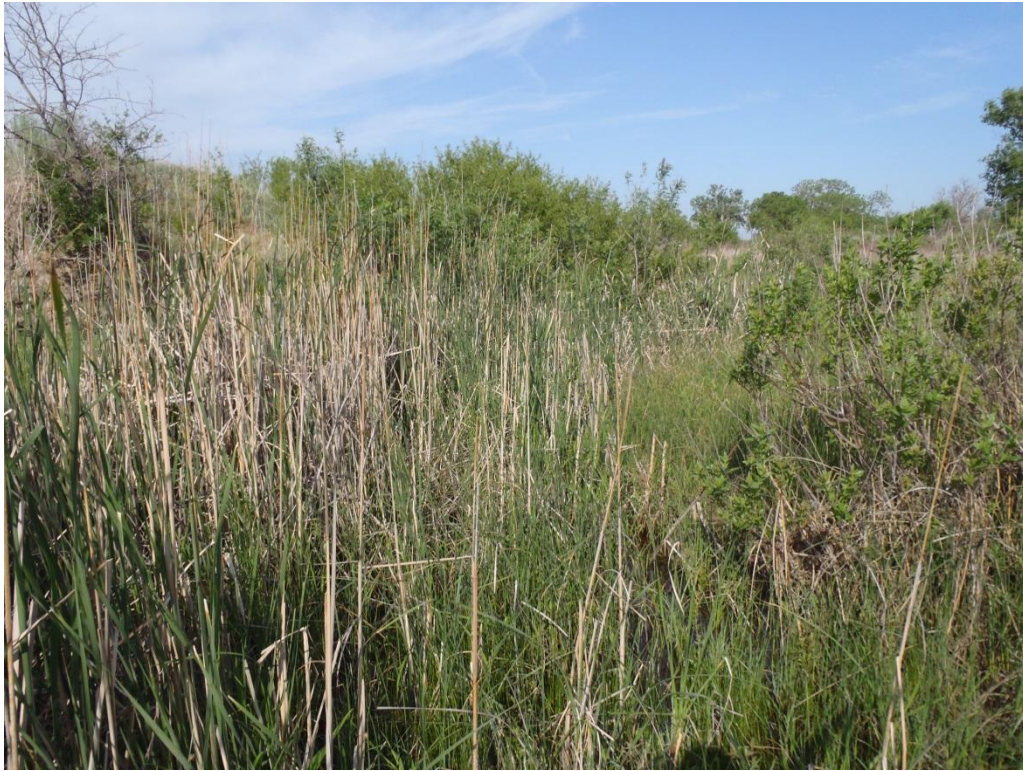
Figure 5.60 Photograph of Sweetwater Creek Site SW025 taken on May 28, 2013, the upstream view of the 150-m transect.

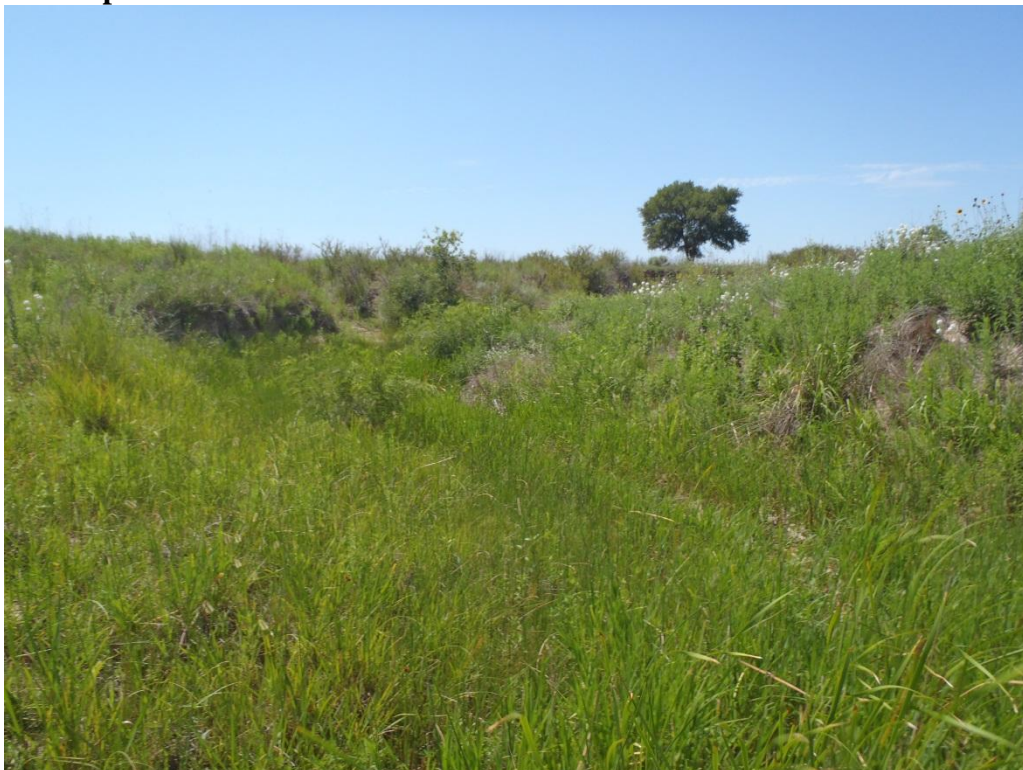
Figure 5.61 Photograph of Sweetwater Creek Site SW025 taken on July 28, 2013, the upstream view of the 30-m transect.

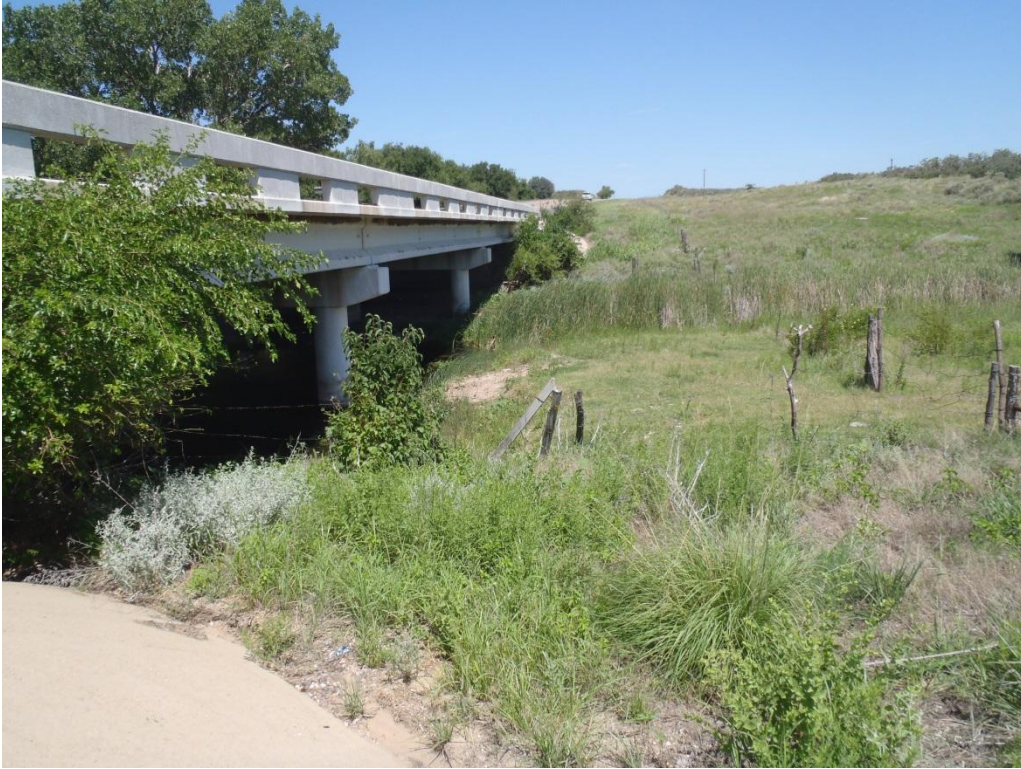
Figure 5.62 Photograph of Sweetwater Creek Site SW026 taken on July 28, 2013 showing the property fences underneath the bridge crossing State Highway 152.

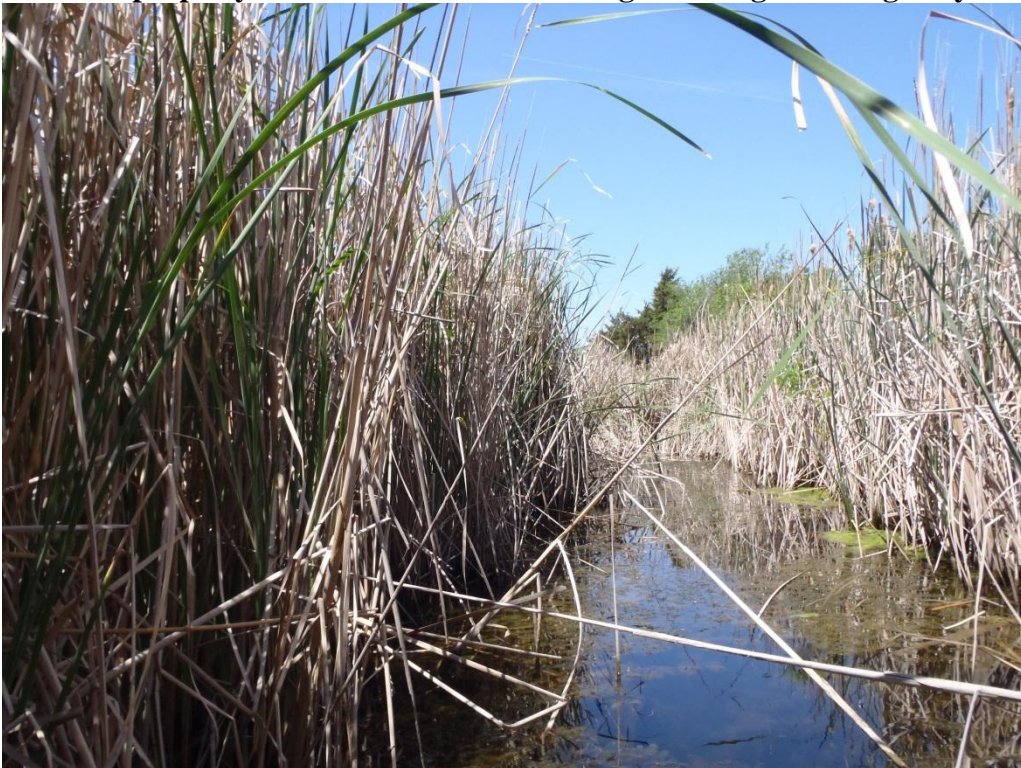
Figure 5.63 Photograph of Sweetwater Creek Site SW026 taken on May 27, 2013, the upstream view of the 150-m transect.

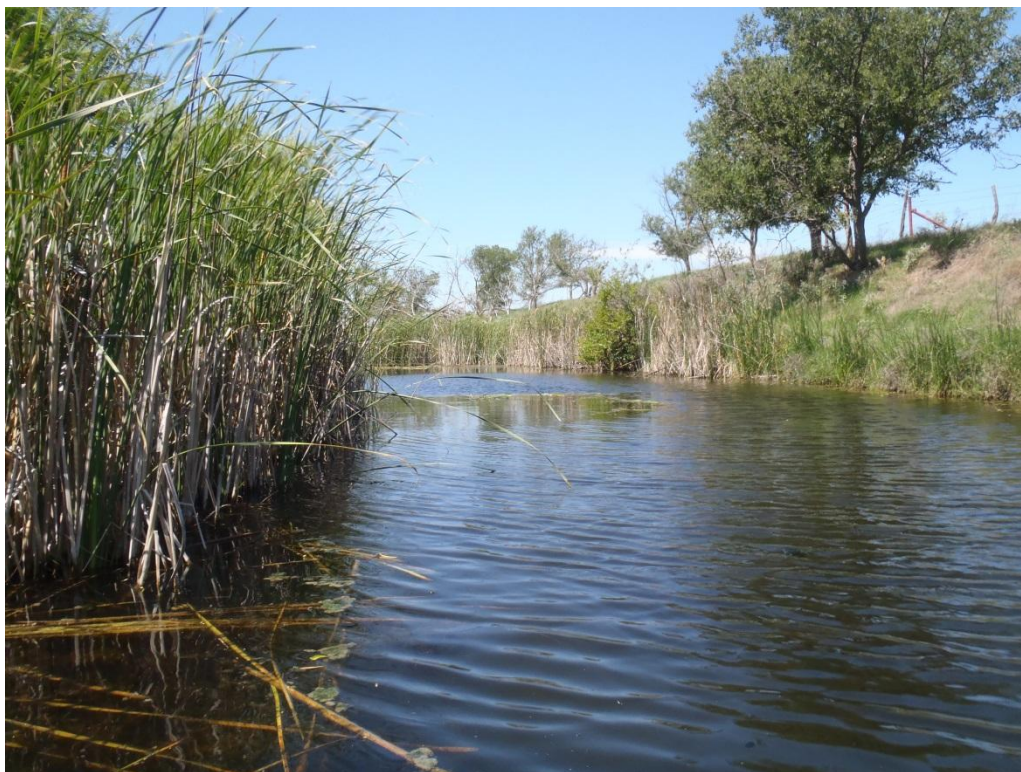
Site SW026 was wadeable for the entire 300-m reach length, although it was challenging due to some deep pools created by beaver dams (Figure 5.64). TIAER personnel carefully waded the edges of the pools to avoid filling their waders. The two pools were observed during both of the surveys in the same locations, between the 180-m and 210-m transects for the first pool and from the 280-m transect to beyond the 300-m transect. The length of the first pool ranged from 25 to 30 meters, with widths of approximately 10 meters and depths over 1.5 meters. The second pool was greater than 50 meters long, as it went well beyond the 300-m transect. Widths of the second pool ranged from 7.5 to 9.0 meters wide with depths also over 1.5 meters. Average thalweg was >0.56 m during the first survey and >0.54 m during the second survey (Table 5.6).

Figure 5.64 Photograph of Sweetwater Creek Site SW026 taken on July 28, 2013, the upstream view of the 300-m transect.

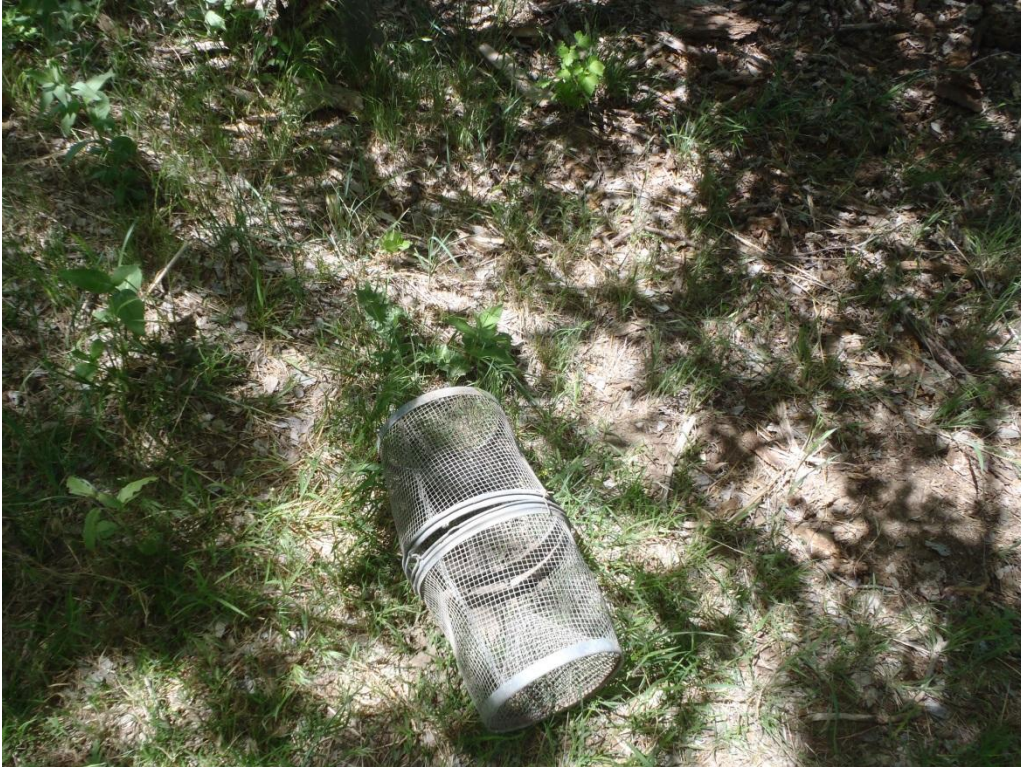
Aesthetic appearance of the water and wildlife observations for the site during each survey have been previously provided in Tables 5.9 and 5.10, respectively. There was a slight presence of snakes during the first survey with no other mammals or vertebrates observed. No animals or vertebrates were encountered during the second survey. Tracks found during both surveys were identified as cattle, raccoon, canine, and deer. Bird and cattle feces were found throughout the reach during both surveys. Aquatic vegetation was abundant during both surveys while algae was common during the first survey and rare during the second survey. Water color was clear with no surface scum and foam observed during either survey. During the second survey, there was an odor to the water, which may have been caused by TIAER personnel disturbing the sludge deposits on the bottom of the stream. Trash, rarely observed during the both surveys, consisted of typical plastics and aluminum cans. The only evidence of human activity within the reach was a minnow trap and a fishing lure, both found on the bank of the stream (Figures 5.65 and 5.66).

Figure 5.65 Photograph of minnow trap at Site SW026 taken on May 27, 2013.

One minnow trap and fishing lure were found at Site SW026. They were found at the large pool near the 300-m transect.

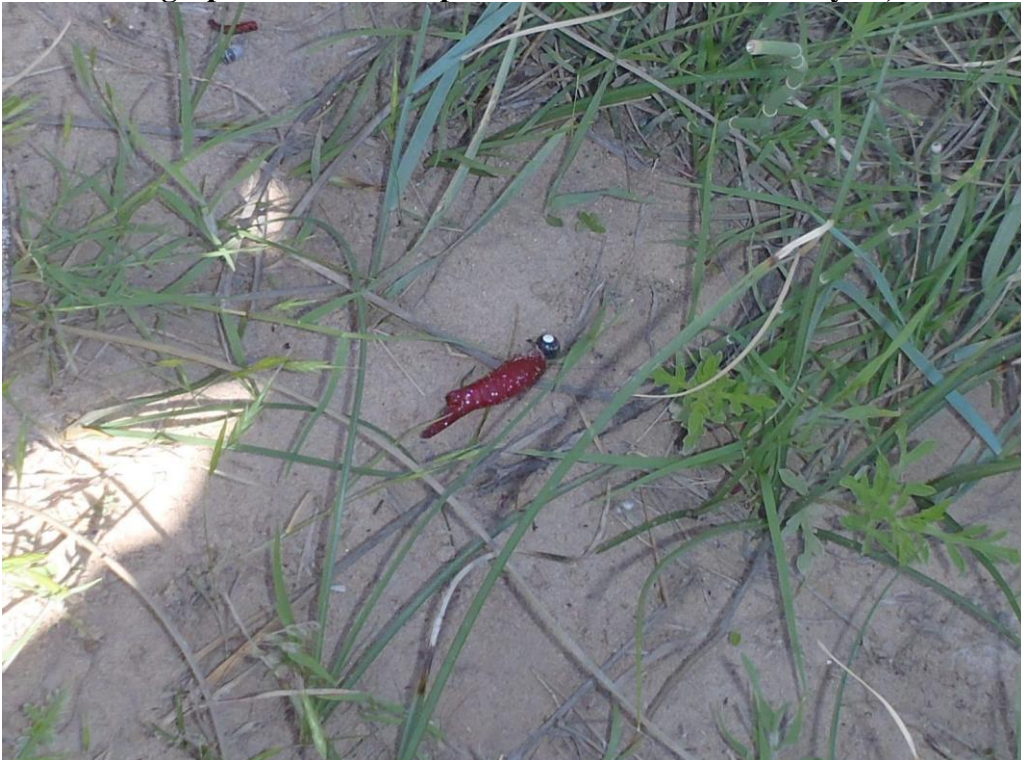
Figure 5.66 Photograph of fishing lure at Site SW026 taken on May 27, 2013.
